Inspector's Daily Report

IDR Sheet 1 of 6 Sheets	
Contract C-7852	Date Friday August 6, 2010

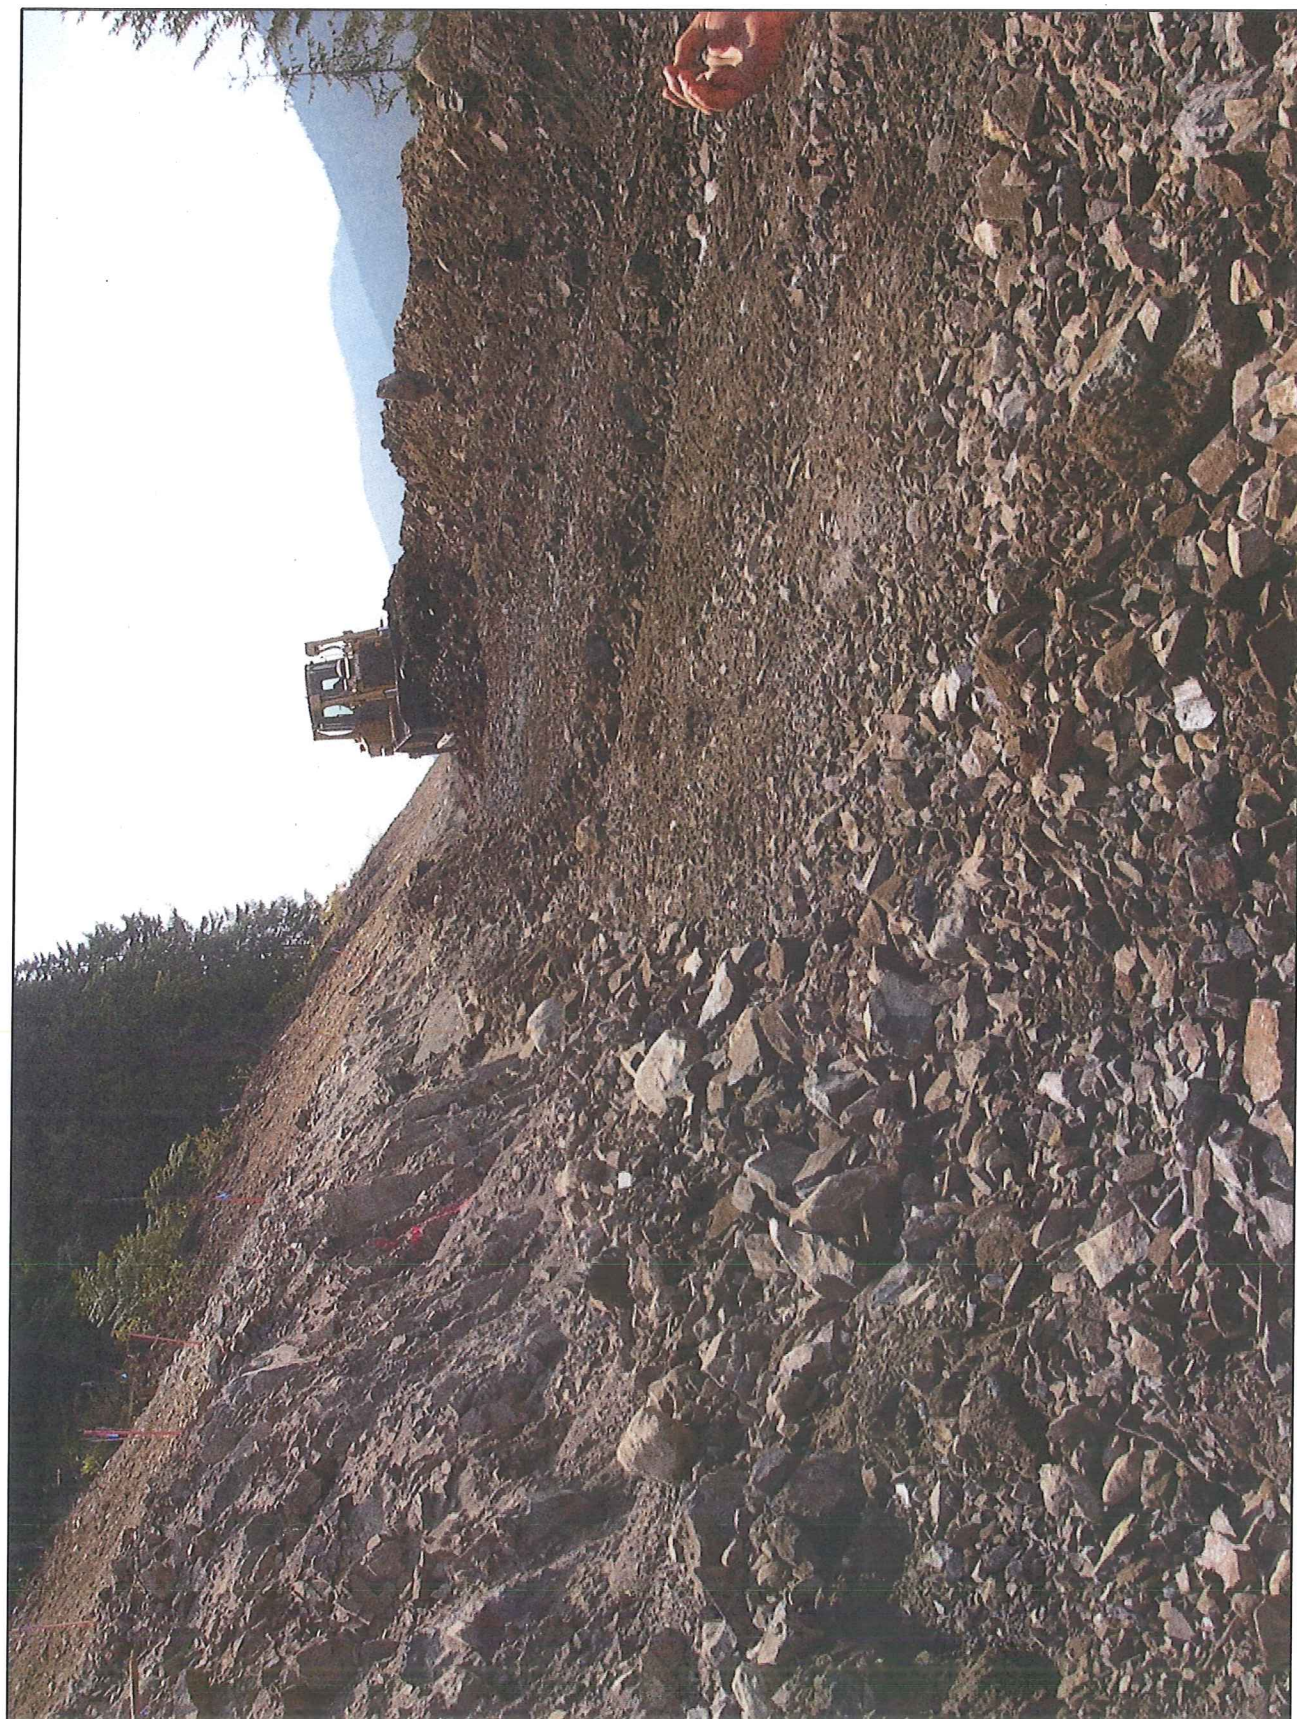
Figure 1: Approximate Station 1320+50 to 1321+00

At the request of the Project Office, I arrived at the project site around 12:00 p.m. for a lift inspection between Stations 1320+75 and 1322+00 and to observe several exploratory drill holes between Stations 1319+25 and 1320+50 (Tom Badger IDR 8-5-10). I met with WSDOT Inspector Brad Schut at the base of the slope and we proceeded onto the cut to the location where today's lift inspection was scheduled. Upon arrival at the location, only about half of the required material had been mucked and the Contractor was not ready for our lift inspection (Figure 1).

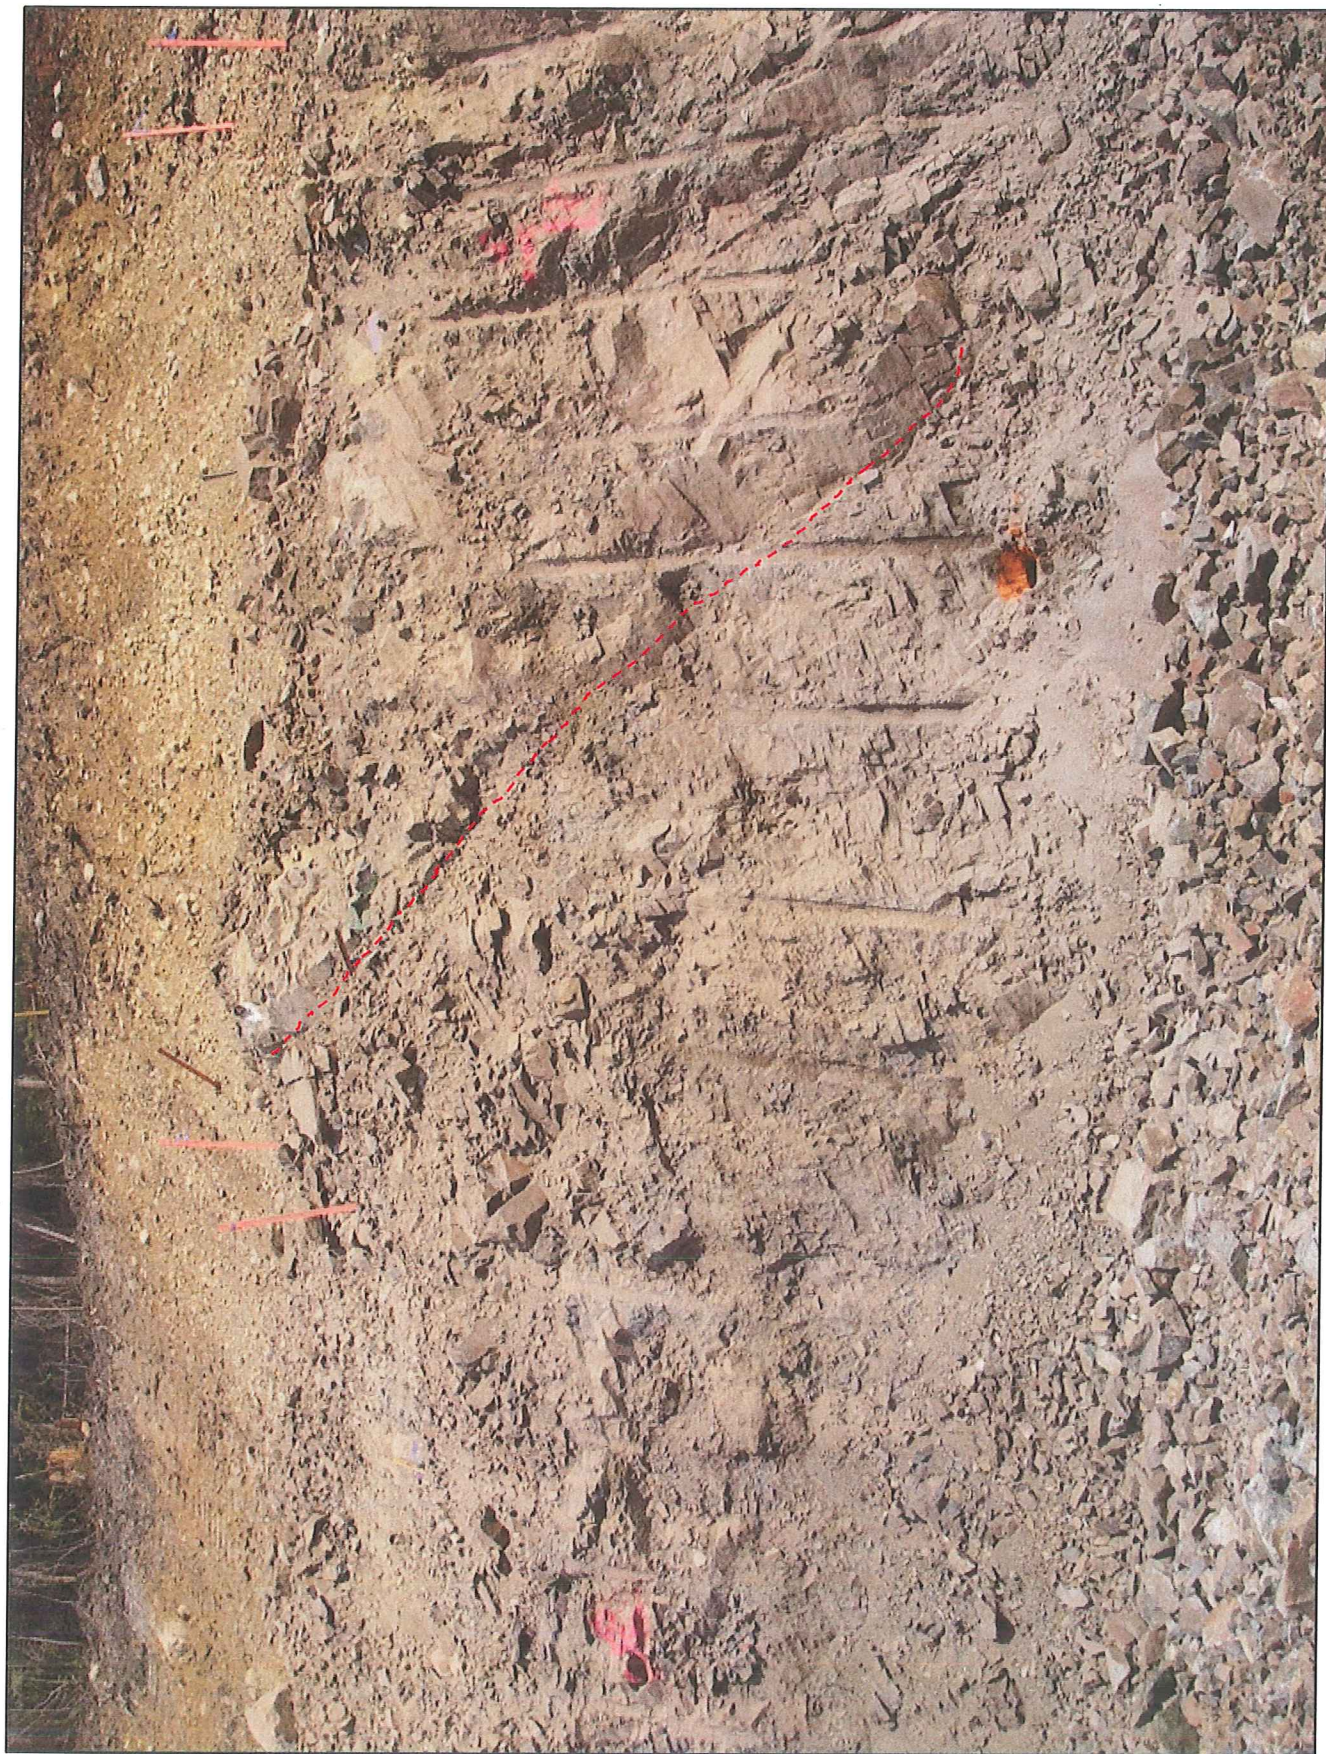
By 3:30 p.m. the Contractor had mucked enough material to reach the lift bottom, approximate elevation 2580, between the approximate Stations 1320+50 and 1321+00. This was approximately 100 ft west of the eastern end of the previous shot location, Station 1320 +75 to 1322+00. I inspected the freshly exposed cut face and observed hard basaltic rock with preserved half casts approximately 30 inches apart with 3 to 24 inch fracture spacing (Figures 2-4). No water was observed and no dowel locations were marked on the cut face. Two CLAR reading (76/296 and 70/310) were obtained from one tight discontinuity feature observed on the cut face with 10 -15 ft of persistence.

Figure 2: Approximate Station 1320+50. Dashed red line is observed discontinuity.
